3'28'
REPORT NO. NADC-80202-60

CRACK PROPAGATION IN ELECTRON BEAM WELDED Ti-6Al-4V

UNDER SPECTRUM LOADING CONDITIONS

C. E. Neu
Aircraft and Crew Systems Technology Directorate
NAVAL AIR DEVELOPMENT CENTER
Warminster, Pennsylvania 18974

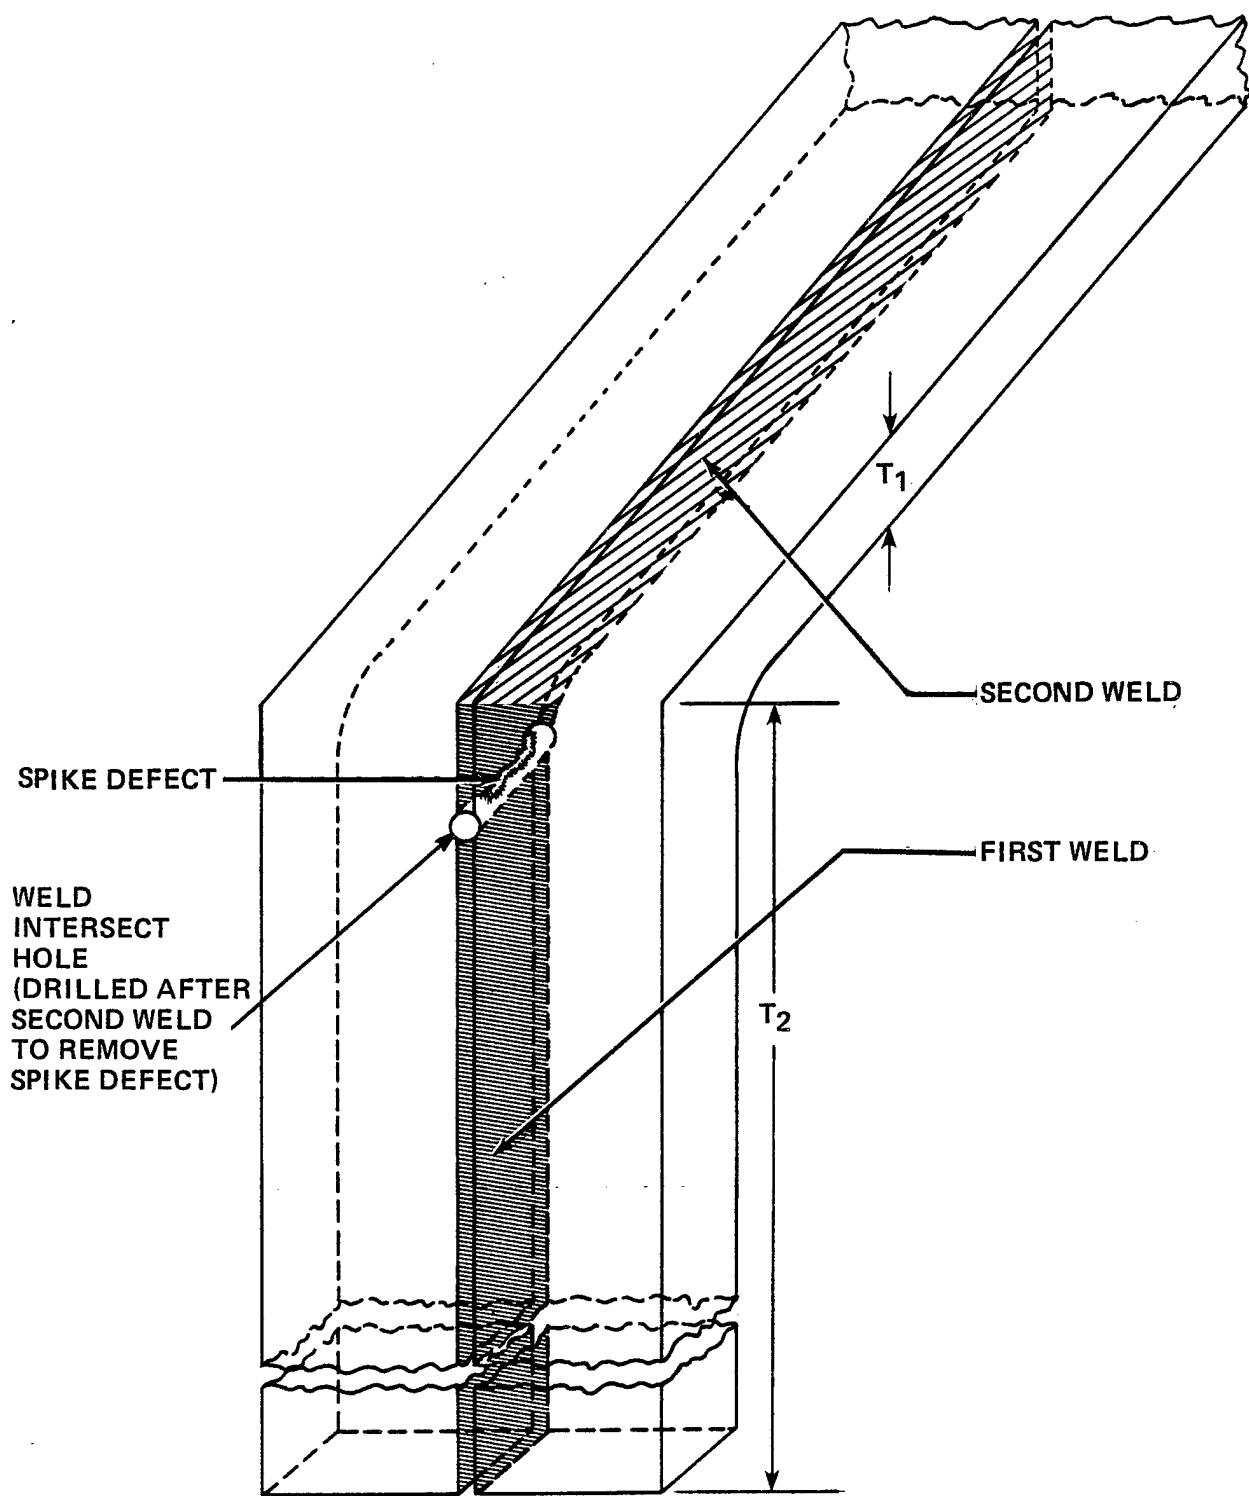
This test program was undertaken as a result of the premature failure of an F-14A aircraft wing carrythrough section test article. The failure occurred by fatigue crack propagation originating at a "spike" defect at a weld intersection point. As shown schematically in Figure 1, a "spike" defect occurs unavoidably when two electron beam welds intersect. After the first weld is completed, the second weld is made with parameters set for thickness T1. When the electron beam encounters the preexisting weld, it "sees" an effective thickness of T2, the entire length of the first weld. A defect occurs at the limit of penetration of the beam. Standard procedure in fabrication of the wing carrythrough section is to remove the defect with a drilled hole. In the case of the fatigue test article, an incompletely removed defect at the surface of the hole escaped detection and served as the failure origin.

Figure 1. Spike Defects and Weld Intersect Holes
